Safety Alert

Lighting Column Failure

13 January 2020

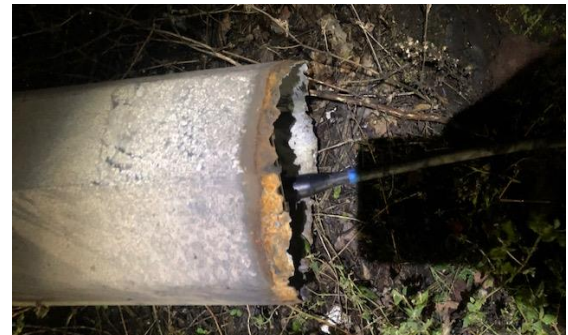
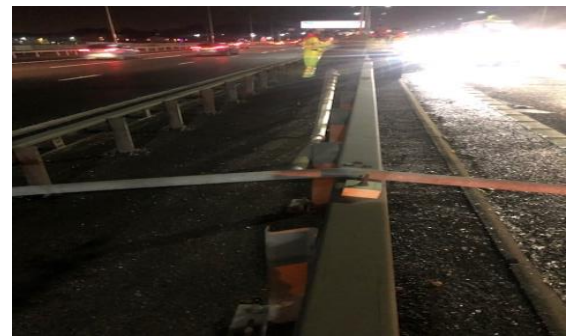
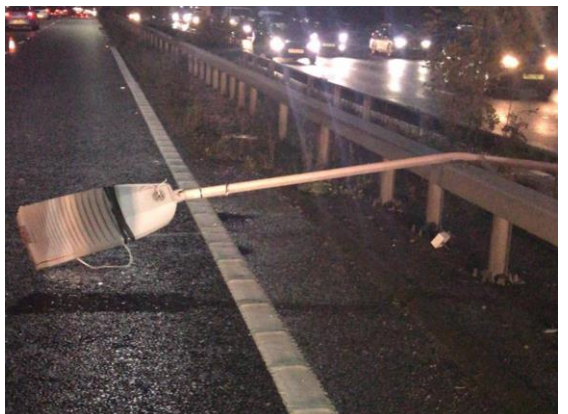
The cause of failure was due to extensive internal corrosion just below ground level.

- The steel columns were 25-year-old and located in an environment exposed to the effects of applying winter road salts, promoting corrosion.
- A detailed structural inspection (including pull testing) was undertaken in 2013, which gave an indicative 5-year residual life.
- Further testing was overdue, but not undertaken as the columns were planned to be removed imminently as part of a major project
- Reliance on visual lamp column inspections alone provides insufficient assurance of column asset condition, particularly below ground level.

- Risk based decisions to depart from Standards should be physically recorded.
- The effects of corrosion requires assessment and effective management.
- Remind Area teams Highways England standards and procedures require physical non-destructive testing of lighting columns over 15 years old.
- SES will consider issuing further guidance with respect to identification of most at risk columns and appropriate physical testing.
