# Safety Bulletin

## Live column with EV CP installed

Issue Number: 46

Date: 20.11.2020

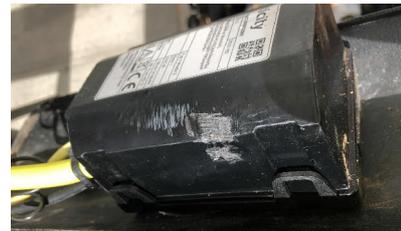
Lamp column was found to be live, emitting smoke and the ground was warm. On removal of column door, it was discovered that the cable between the DNO cutout and the fuse, had been trapped between the rear of the EV CP socket (located in the door) and the column earth (located next to the aperture for the door)

2. Damage to rear of charger. Cable was trapped between scratch marks and earth stud

Notify all suppliers of the incident and advise them as to the importance of cable management within column.

Installation & Maintenance guidance shall now include the following instruction *"If difficulty encountered refitting door at end of installation, STOP and check for obstructions."*

Take photographic evidence of risks and report them to Siemens and supervisor. Detail use of any protection needed for obstructions e.g. stud caps or tape.

Never use excessive force to close the door. If issue cannot be resolved immediately, report to supervisor.
