New 600C Cabinet Damage

On 15th April 2021 during a planned visit by a BMJV sub-contractors, heat / burn damage to cables was discovered at a newly installed 600C cabinet. The incident was immediately reported and an investigation was started.

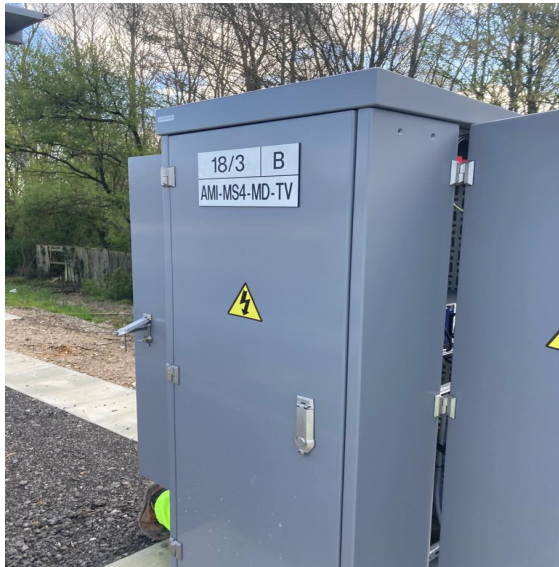
New cabinet

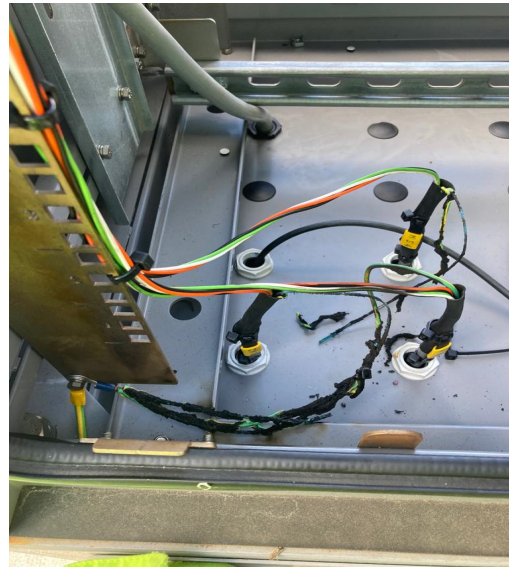
Damaged cables inside

- The Neutral conductor had become live within the Electrical Interface unit on the project boundary, meaning there was a high risk of electric shock as all the metal work on the external cabinet was live (240 Volts).
- Further checks were then made to the incoming DNO supply cable and readings showed that both the Live and Neutral conductors were both carrying a supply voltage.

- The report from DNO Company (SSE) stated that a connection fault had occurred from outside of the site boundary on the incoming DNO supply cable feeding the electrical interface unit and that the fault had caused the damage inside the new site 600c unit.

- Outgoing cables from the electrical interface unit to the new 600C cabinet were isolated.
- Barriers erected around the boundary electrical interface unit and area made safe
- Watchman put in place to prevent anyone accessing the area.
- bmJV AP contacted DNO Company to arrange for them to be called out to deal with the problem.

- The reporting process within the scheme was well executed and the initial investigation was carried out in a safe and concise manner.
- The following points are the recommended checks that all electricians / technicians going into an Electrical Interface cabinet on Highways should do.
 - With a Non-Contact voltage detector check to see if the shell of the metal cabinet is live.
 - Once satisfied that it isn't live, open the doors and remove the covers to the MCX0164 box.
 - Using an approved voltage tester and proving unit check tester with the proving unit.
 - Then check polarity and voltage present on the correct conductors.
 - Re-check tester using the proving unit.
 - Close up covers and doors.
 - Record and leave site.
