## Undermining of Street Lighting Columns

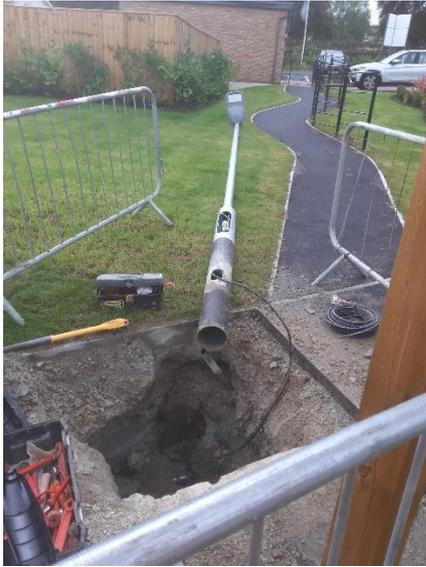
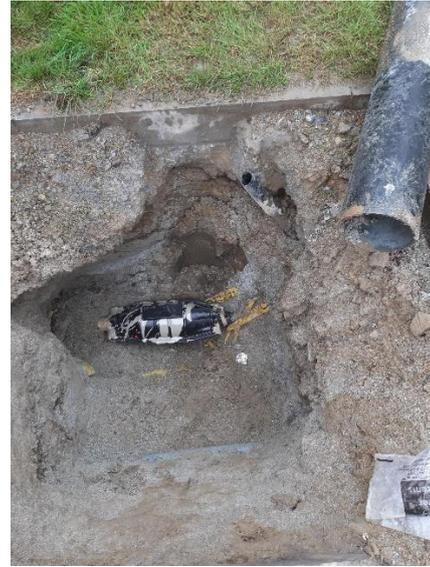
There have been a couple of recent near misses reported where excavations for joint pits have undermined nearby street lighting columns with the potential for them to collapse and on one recent occasion, where it did. In this instance the street lighting column was prevented from coming down on to the Joiner (by his Mate) who was in the excavation finishing off the service joint to it.

- All jointing activities are to be risk assessed and where the hazard from undermining structures including street lighting columns is considered likely, operatives are **NOT** to undertake the work as there is a high risk of the column collapsing leading to severe injury of the individual and/or others including members of the public.
- The operative is to report this type of hazard immediately to both the Site Manager and their respective Engineer and record the fact on the Site Specific Risk Assessment, then raise an abortive job which must include a photo with any additional notes.
