Safety Alert

Removing fuse from street lighting column – Potential for burns

Ref: SHE H170 A BCC Arc Flash
Issued by: Kier Highway SHE
Department
Date: 18/08/2020

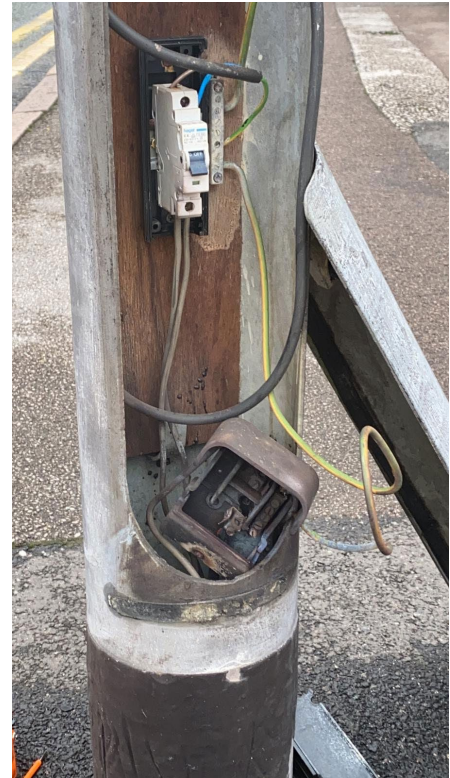
A street lighting electrician was isolating a mains supply to replace a damaged secondary isolator in a sign column. When removing the mains fuse carrier, the live and neutral arced and causing a flash fire.

The **preventative** control measure – isolating the column **failed** the investigation showed that the insulation on the live and neutral had shrunk over time, pulling the fuse brought them close enough to arc.

The **Mitigation** control measure – arc flash PPE was effective he sustained no injuries from the 1000°C flash.

1. Always check electrical components for signs of visible damage.
2. If you are unsure about condition request the DNO isolate the supply upstream.
3. Always follow your safe system of work and training.
4. Wear the correct PPE for the task
5. Behave responsibly at all times, maintain your situational awareness during high risk activities.
